CIC Safety Message No. 020 / 22

FATAL ACCIDENT AT TUEN MUN RECYCLING PLANT THE PERSON-IN-CHARGE WAS STRUCK BY THE I-BEAM AND DIED

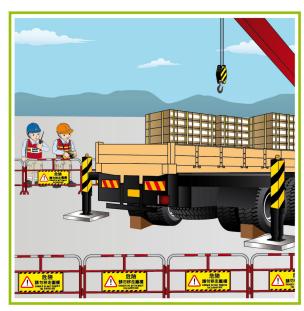
The fatal zone should be barricaded before lifting operation.
