SUDDEN DESCENT OF GONDOLA TRAPPING TWO WORKERS

CIC Safety Message No. 012 / 22

SAFETY OF SEP (GONDOLA) OPERATION

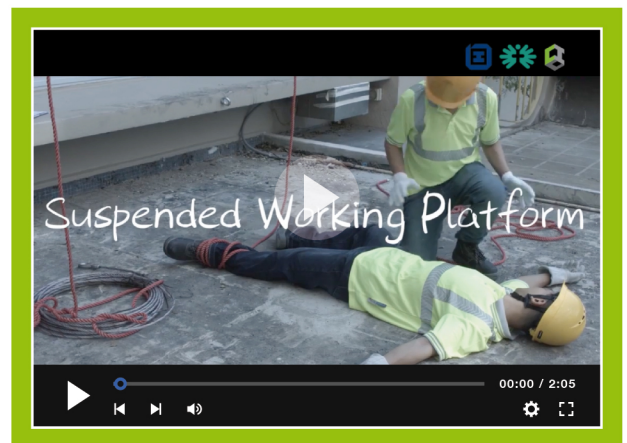
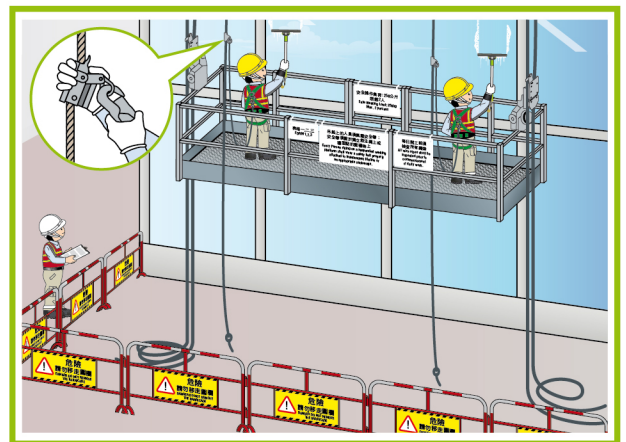
Another incident regarding Gondola happened on 25 June 2022 shortly after the previous incident in June. Luckily this accident caused no serious injuries.

1. Ensure the Gondola is properly installed and anchored in accordance with manufacturer's specification and under the advice of professional engineers.
2. Ensure the Gondola is certified safe after load test and thorough examination was done by competent person before use.
3. Ensure all workers on a Gondola wear a safety belt attached to an independent lifeline.
4. Ensure the working zone is effectively fenced off to prevent disturbance to gondola during operation.
5. Appoint on-site supervisor to ensure the operation is in accordance with procedures.
