## Industrial Accident (October 2021)

An accident happened on 8 October 2021 at a building renovation site in Happy Valley in which a worker was trapped under a collapsed bamboo scaffold and was certified dead in the hospital.

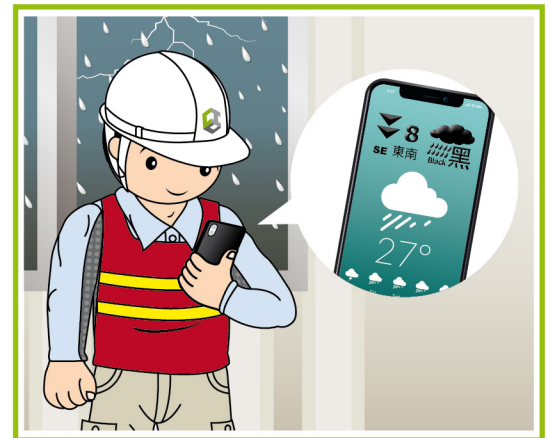
Management keeps monitoring weather conditions and makes suitable arrangements.

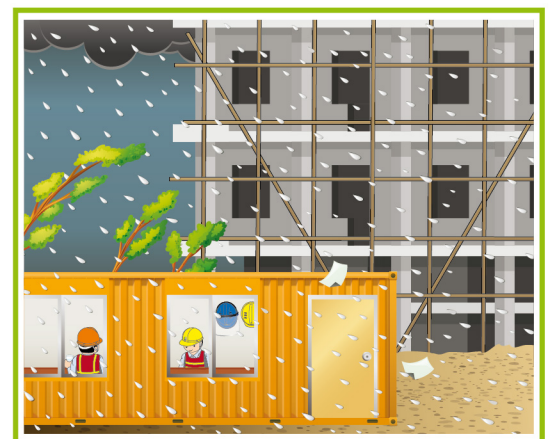
Workers stay in safe environment.
